**APPENDIX E:**

**PHASE 2 DATA QA/QC SUMMARY**

## **Mill Brook Phase 2 SGA QA**

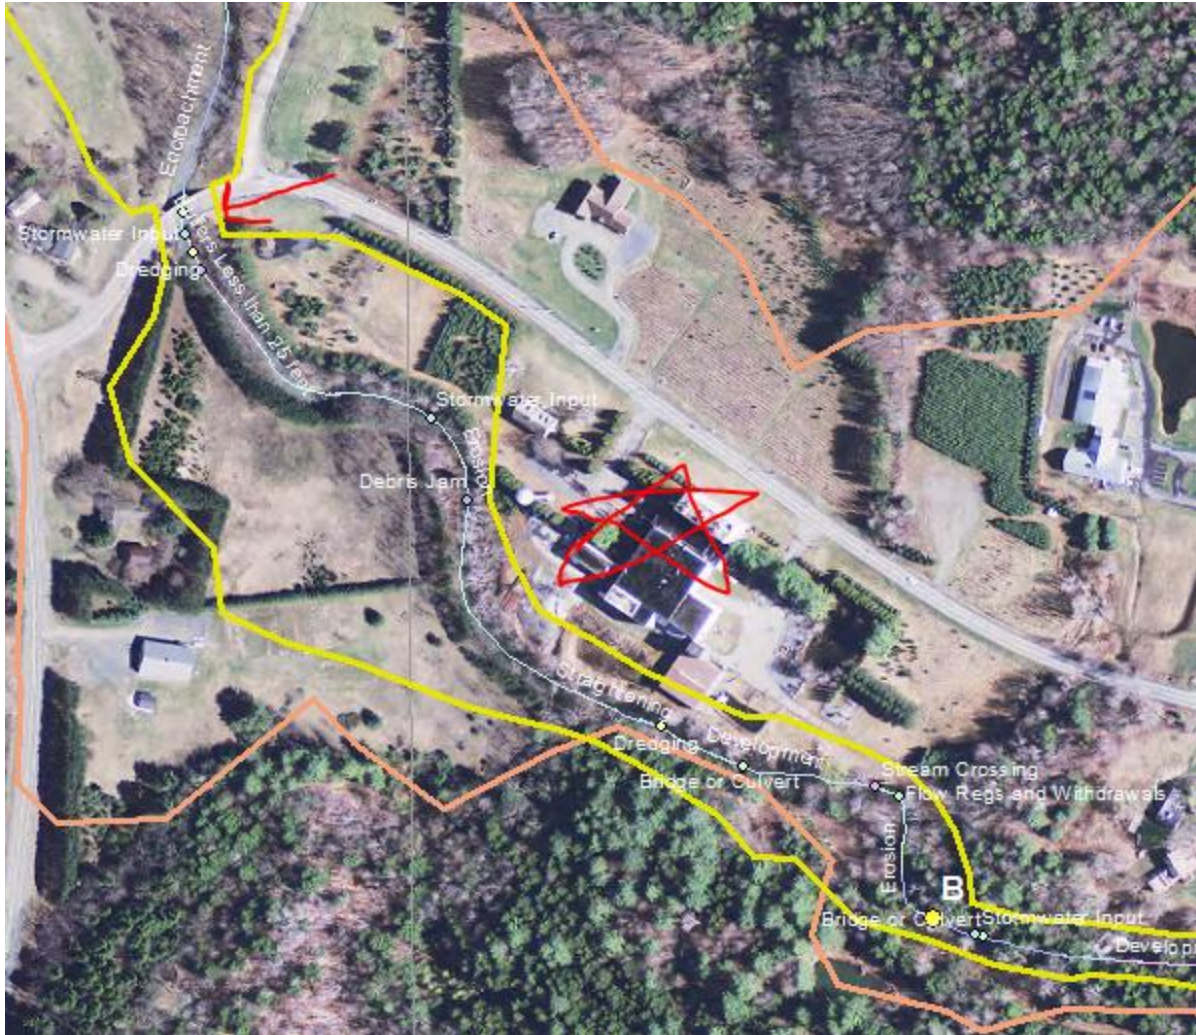
#### **M12-B**

I have visited this site for an Act 250 case so am somewhat familiar with the lay of the land, and wonder about your valley wall delineation. This structure (red star) had water flowing through it during Irene, so I think it should be mapped within the valley (I think the left vw is somewhere on the opposite side of the road). I wonder if maybe the high banks were somewhat deceiving while you were mapping given the extreme level of incision that has occurred there?

**Yes, this is likely true.**

Also, I notice that you are mapping the valley wall based on road fill at road crossings. In these situations please approximate the valley wall in the absence of road fill. That is, if the bridge is on ledge, go ahead and map the valley wall that acknowledges the presence of an unerodible feature, but if there is fill at the approaches, map it as if the fill were not there. This results in smoother transitions of the river corridor at road crossings and helps acknowledge that road fill is vulnerable to catastrophic erosion at undersized crossings during flood events.

**Edited VW to include the building and expanded at the bridge fill. We will use this approach for future VW mapping.**
