APPENDIX E:

PHASE 2 DATA QA/QC SUMMARY

Mill Brook Phase 2 SGA QA

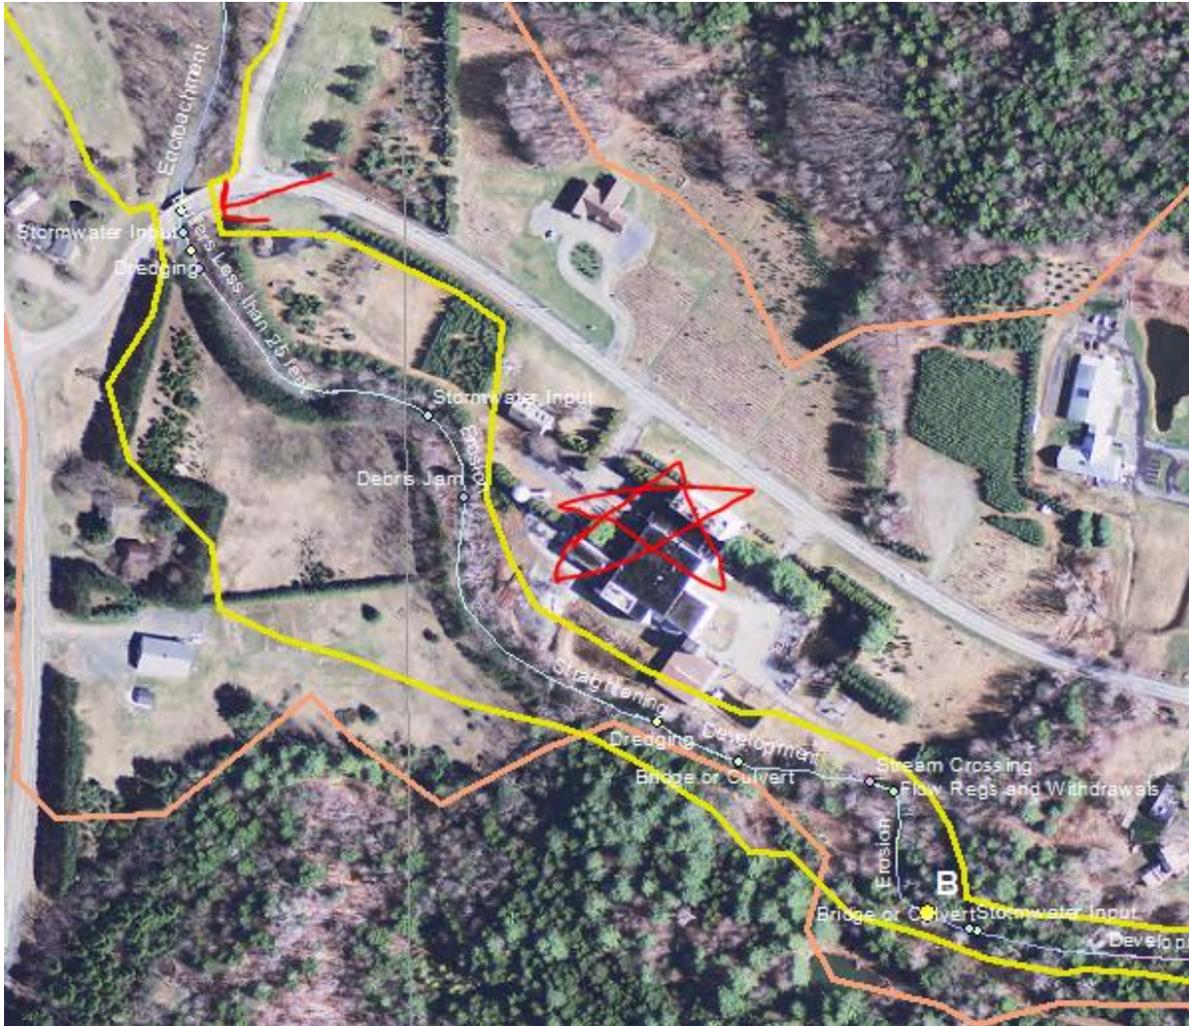
Also, I notice that you are mapping the valley wall based on road fill at road crossings. In these situations please approximate the valley wall in the absence of road fill. That is, if the bridge is on ledge, go ahead and map the valley wall that acknowledges the presence of an unerodible feature, but if there is fill at the approaches, map it as if the fill were not there. This results in smoother transitions of the river corridor at road crossings and helps acknowledge that road fill is vulnerable to catastrophic erosion at undersized crossings during flood events.

Edited VW to include the building and expanded at the bridge fill. We will use this approach for future VW mapping.
